Maryland Inventory of Historic Properties number: WA-I-735

Name: 21026/MD6Z OVER LITTLE ANTIETAM CRK.

MARYLAND INVENTORY OF HISTORIC BRIDGES  
HISTORIC BRIDGE INVENTORY  
MARYLAND STATE HIGHWAY ADMINISTRATION/  
MARYLAND HISTORICAL TRUST

SHA Bridge No. 21026 Bridge name MD 62 over Little Antietam Creek

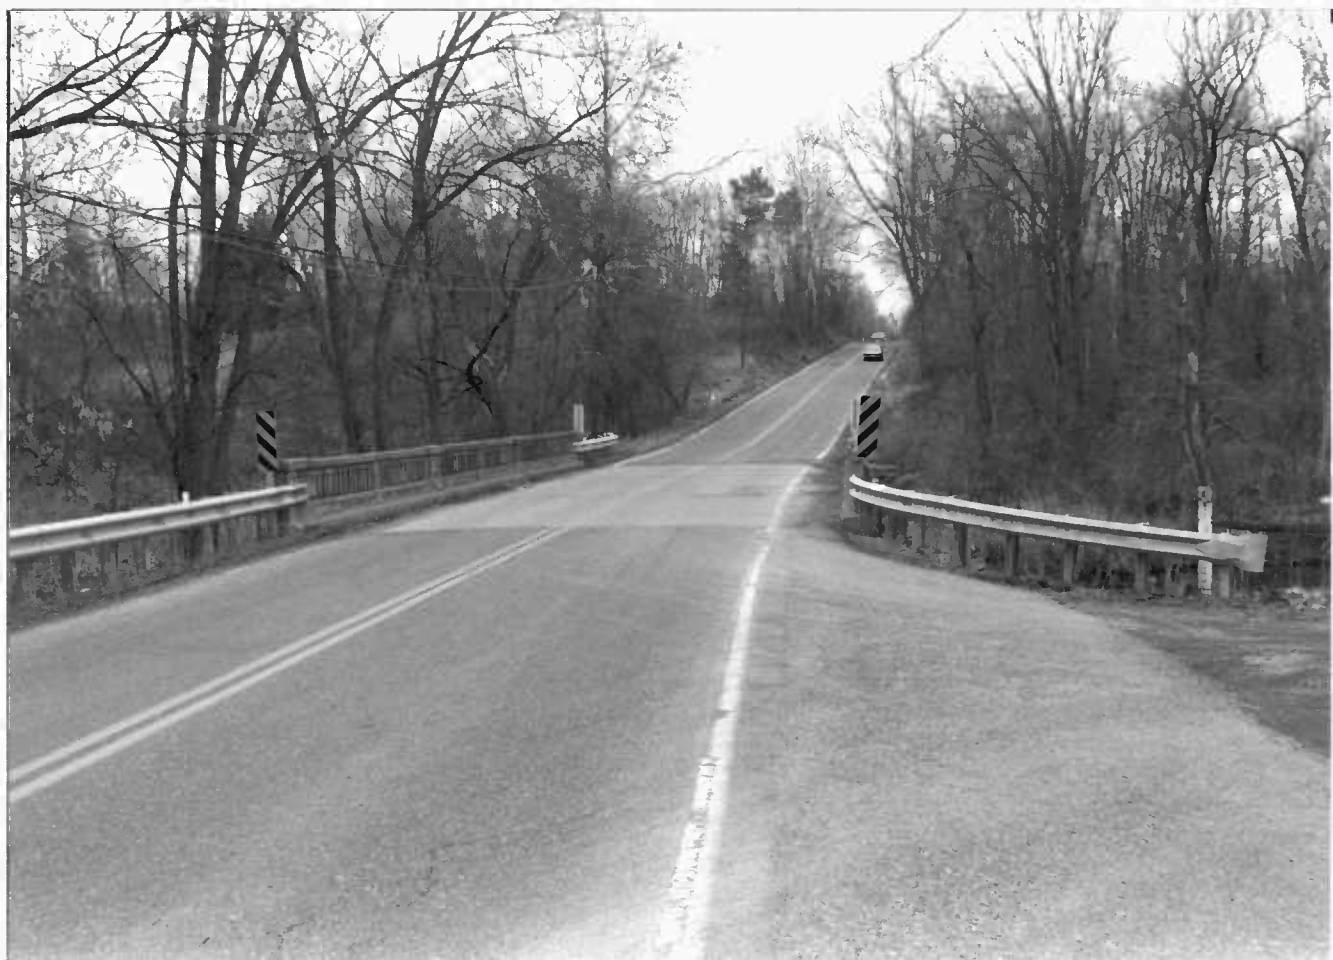
< OF 4

1: P. 22512 1111 435  
OVER LITTLE ANTHELIAM CREEK  
WASHINGTON CO. MD.  
CHARLES E. BAKER  
2/22/45

SOUTH AFRICA

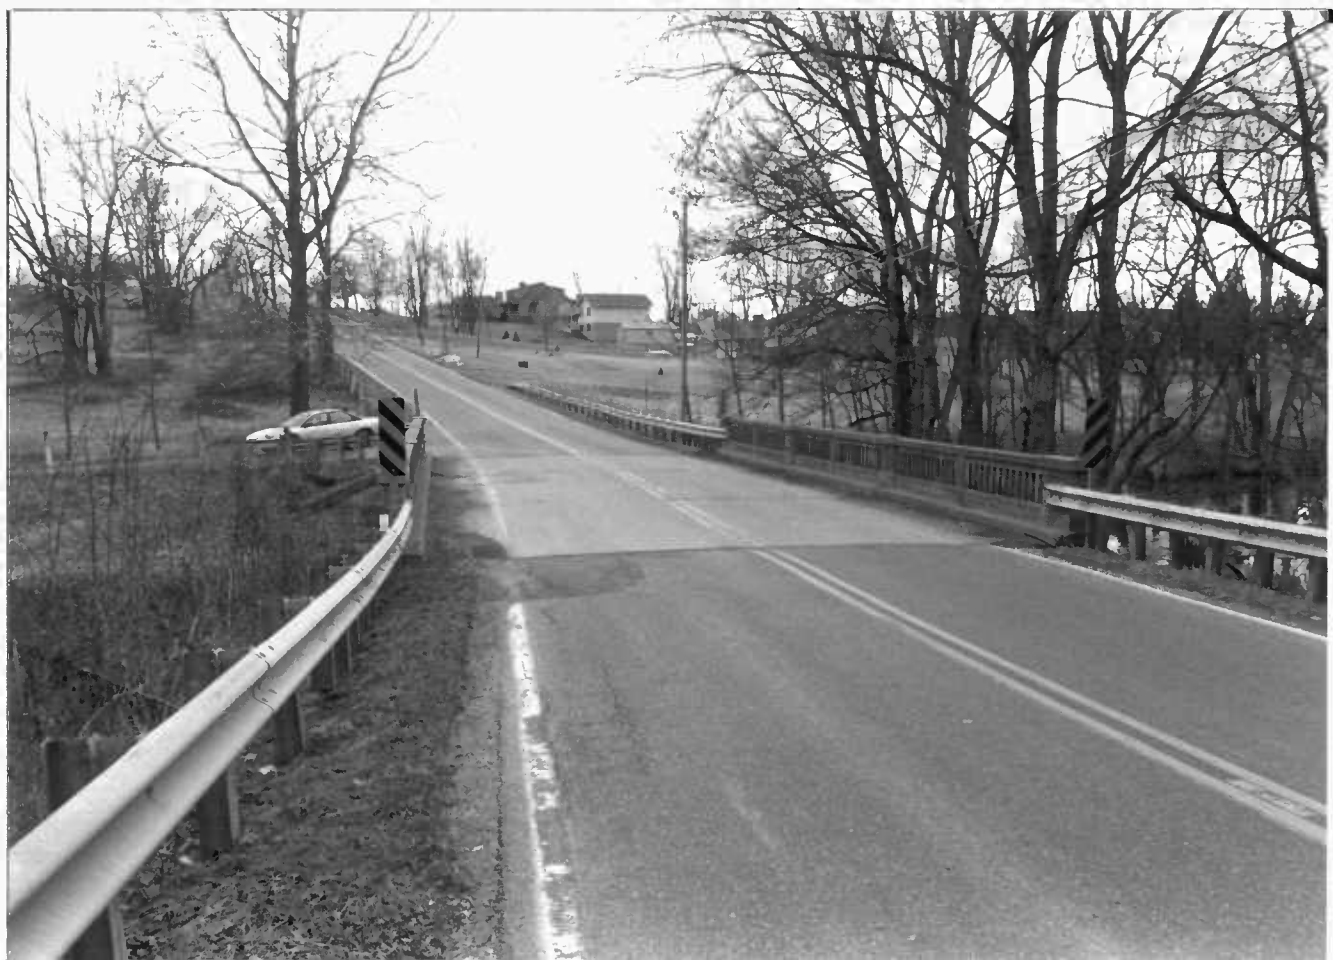
3 OF 9

BR = ~~NEW~~ J. J. G. W. N. 1. 1950  
OVER LITTLE ANTICATHARIS RECK  
WASHINGTON CO., MD.  
11/21/50 21/11/50  
2 12/19/50  
S. L. A.

NORTH A. 1950

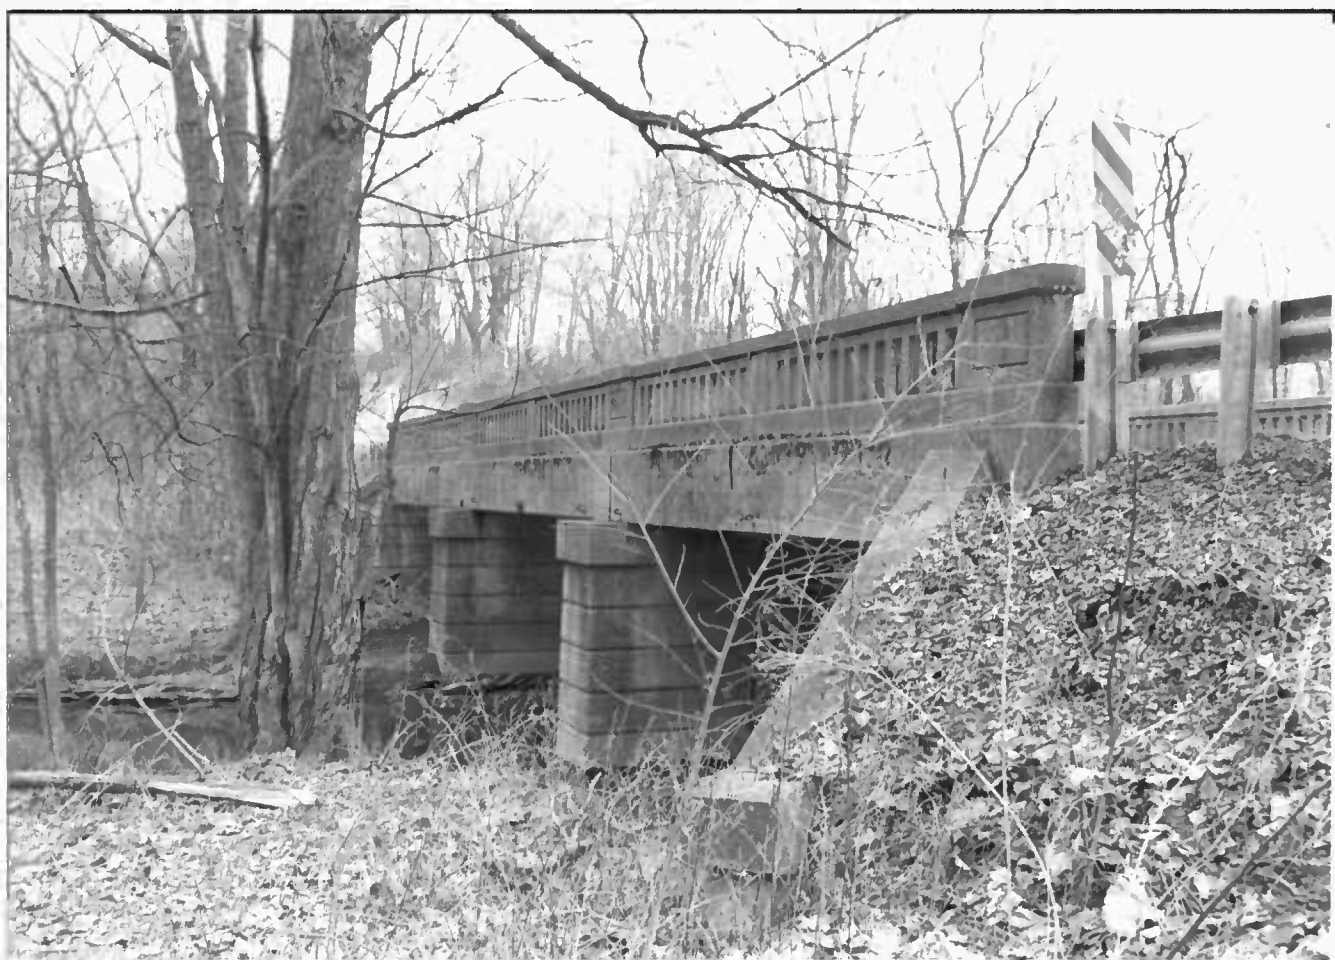
4 of 4

WEST LIT. OF (UPSTREAM)
